Home Report

Scottish Single Survey

Single Survey

Property address	Pinewood Ythanwells Huntly AB54 6AY
Customer	Mrs Margaret Metcalf
Customer address	Pinewood Ythanwells Huntly AB54 6AY
Prepared by	Shepherd Chartered Surveyors
Date of inspection	20/06/2024

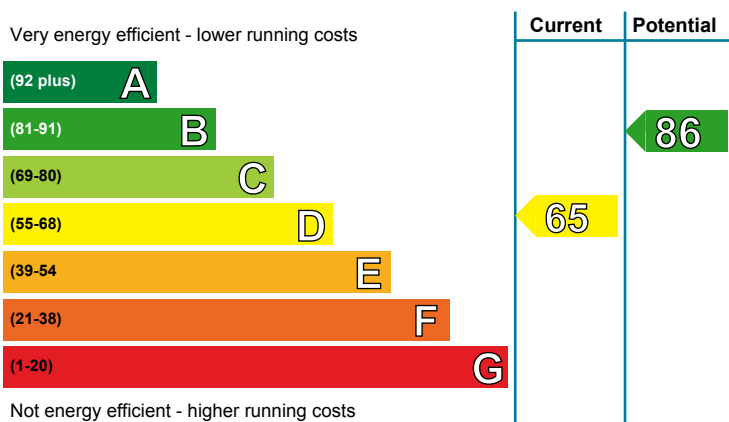
Energy Efficiency Rating

This graph shows the current efficiency of your home, taking into account both energy efficiency and fuel costs. The higher this rating, the lower your fuel bills are likely to be.

Your current rating is **band D (65)**. The average rating for EPCs in Scotland is **band D (61)**.

The potential rating shows the effect of undertaking all of the improvement measures listed within your recommendations report.

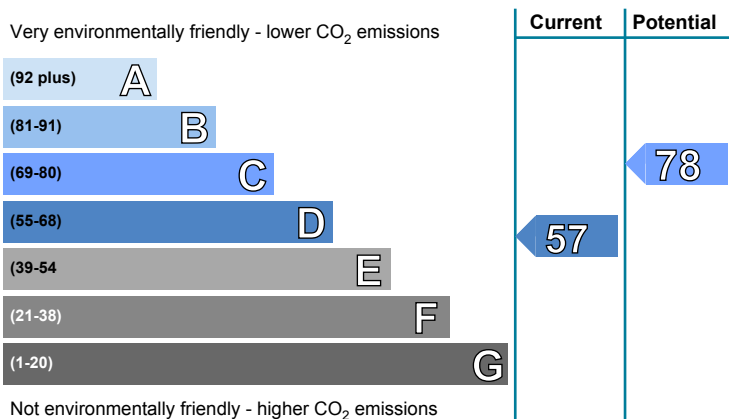
Environmental Impact (CO₂) Rating

This graph shows the effect of your home on the environment in terms of carbon dioxide (CO₂) emissions. The higher the rating, the less impact it has on the environment.
