**Walker Fraser Steele**  
**Chartered Surveyors**

Reekie Farmhouse

## Energy Performance Certificate

# Single Survey

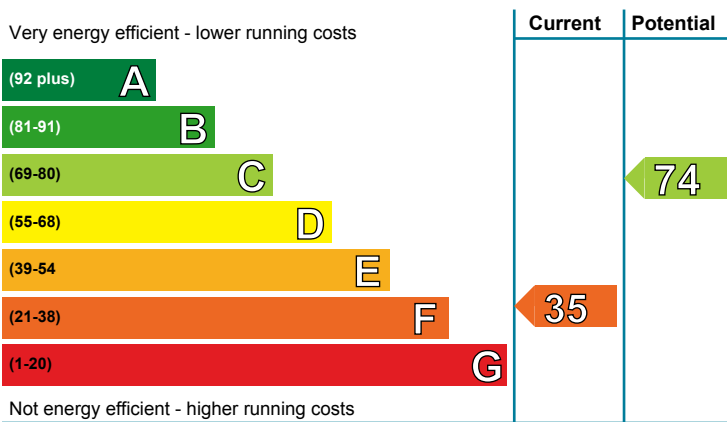
## Energy Efficiency Rating

This graph shows the current efficiency of your home, taking into account both energy efficiency and fuel costs. The higher this rating, the lower your fuel bills are likely to be.

Your current rating is **band F (35)**. The average rating for EPCs in Scotland is **band D (61)**.

The potential rating shows the effect of undertaking all of the improvement measures listed within your recommendations report.

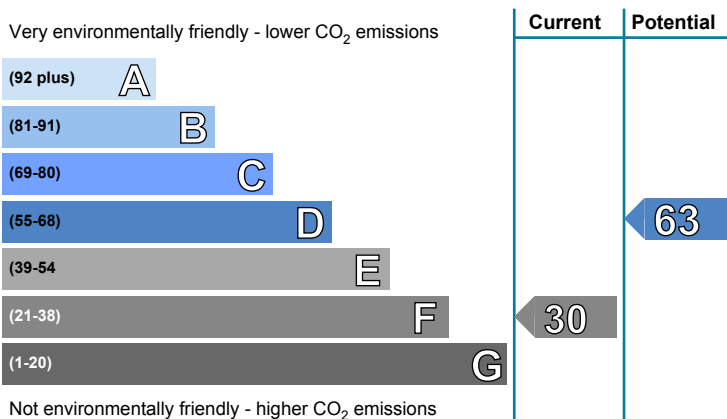
## Environmental Impact (CO<sub>2</sub>) Rating

This graph shows the effect of your home on the environment in terms of carbon dioxide (CO<sub>2</sub>) emissions. The higher the rating, the less impact it has on the environment.

Your current rating is **band F (30)**. The average rating for EPCs in Scotland is **band D (59)**.

The potential rating shows the effect of undertaking all of the improvement measures listed within your recommendations report.
