HOME REPORT

9 INCH ROAD
KELSO
TD5 7BU

Energy Performance Certificate (EPC)

9 INCH ROAD, KELSO, TD5 7BU

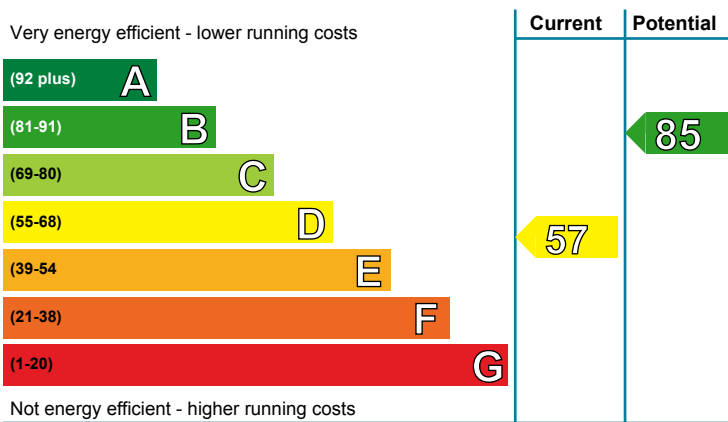
Energy Efficiency Rating

This graph shows the current efficiency of your home, taking into account both energy efficiency and fuel costs. The higher this rating, the lower your fuel bills are likely to be.

Your current rating is **band D (57)**. The average rating for EPCs in Scotland is **band D (61)**.

The potential rating shows the effect of undertaking all of the improvement measures listed within your recommendations report.
