Home Report

Scottish Single Survey

| Property address | Catrine Mains Catrine Mauchline KA5 6HP |

**Energy
Performance
Certificate**

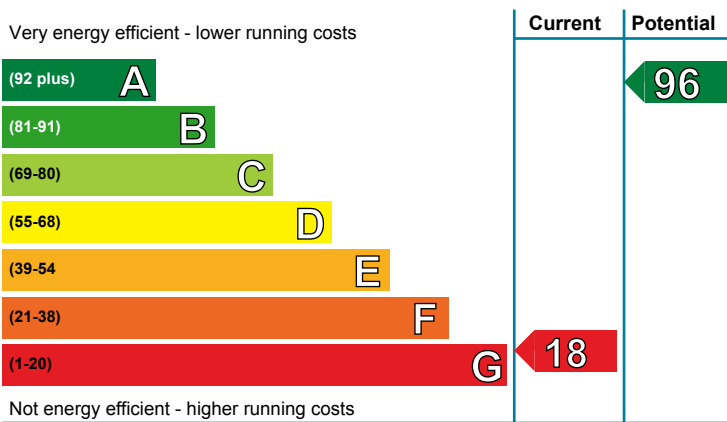
Energy Efficiency Rating

This graph shows the current efficiency of your home, taking into account both energy efficiency and fuel costs. The higher this rating, the lower your fuel bills are likely to be.

Your current rating is **band G (18)**. The average rating for EPCs in Scotland is **band D (61)**.

The potential rating shows the effect of undertaking all of the improvement measures listed within your recommendations report.

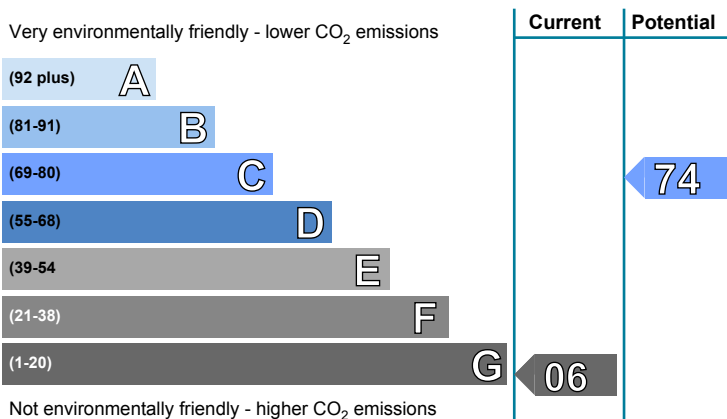
Environmental Impact (CO₂) Rating

This graph shows the effect of your home on the environment in terms of carbon dioxide (CO₂) emissions. The higher the rating, the less impact it has on the environment.
