Home Report

Gardeners Cottage Methven PH1 3SU

Date of Valuation: 08/07/2024

Property address	Gardeners Cottage Methven
	PH1 3SU

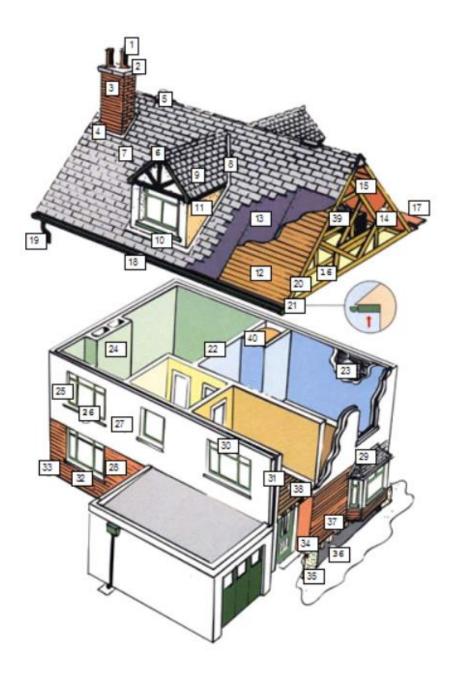
Sectional Diagram showing elements of a typical house

1 Chimney pots 2 Coping stone 3 Chimney head Flashing 4 **Ridge ventilation** 5 Ridge board 6 7 Slates/tiles 8 Valley guttering 9 Dormer projection 10 Dormer flashing 11 Dormer cheeks 12 Sarking Roof felt 13 14 Trusses Collar 15 16 Insulation Parapet gutter 17 18 Eaves guttering 19 Rainwater downpipe Verge boards / skews 20 Soffit boards 21 Partition wall 22 Lath / plaster 23 24 Chimney breast 25 Window pointing 26 Window sills 27 Rendering 28 Brickwork / pointing 29 Bay window projection 30 Lintels Cavity walls / wall ties 31 32 Subfloor ventilator Damp proof course 33 34 Base course 35 Foundations 36 Solum 37 Floor joists 38 Floorboards 39 Water tank 40 Hot water tank
