Home Report

BLACKFORD HOME FARM
ROTHIENORMAN

INVERURIE
AB51 8YL

Energy Performance Certificate (EPC)

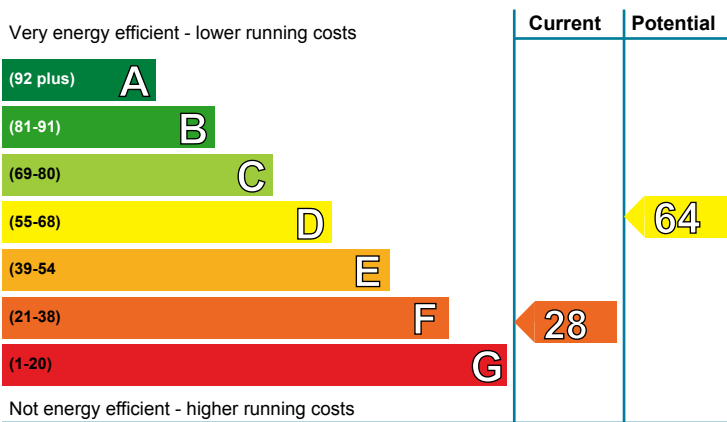
Energy Efficiency Rating

This graph shows the current efficiency of your home, taking into account both energy efficiency and fuel costs. The higher this rating, the lower your fuel bills are likely to be.

Your current rating is **band F (28)**. The average rating for EPCs in Scotland is **band D (61)**.

The potential rating shows the effect of undertaking all of the improvement measures listed within your recommendations report.

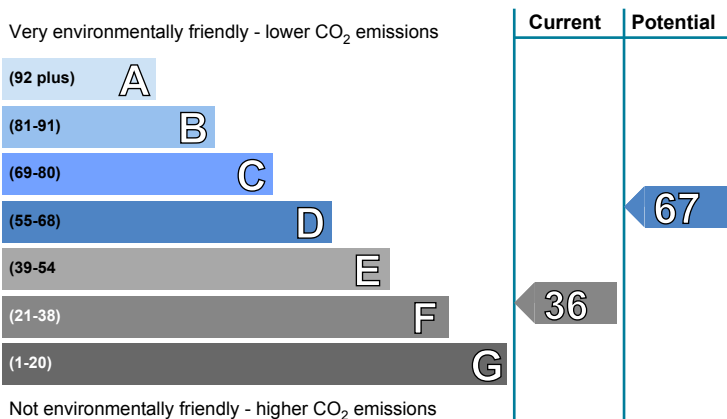
Environmental Impact (CO₂) Rating

This graph shows the effect of your home on the environment in terms of carbon dioxide (CO₂) emissions. The higher the rating, the less impact it has on the environment.

Your current rating is **band F (36)**. The average rating for EPCs in Scotland is **band D (59)**.

The potential rating shows the effect of undertaking all of the improvement measures listed within your recommendations report.
