HOME REPORT

GREENHOWE STEADING BANCHORY DEVENICK

ABERDEEN
AB12 5YJ

Energy Performance Certificate (EPC)

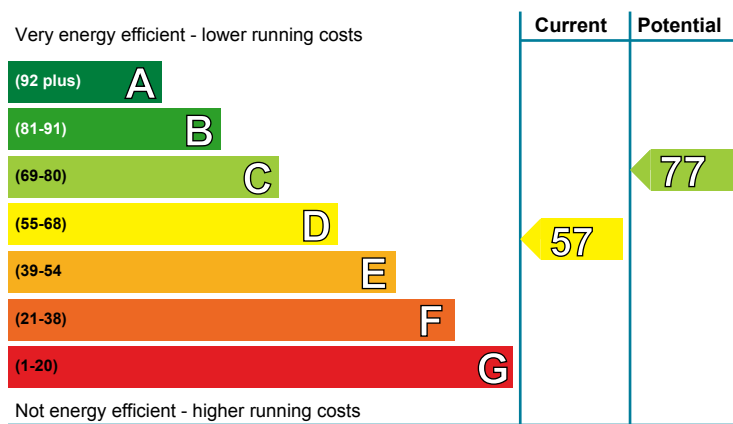
Energy Efficiency Rating

This graph shows the current efficiency of your home, taking into account both energy efficiency and fuel costs. The higher this rating, the lower your fuel bills are likely to be.

Your current rating is **band D (57)**. The average rating for EPCs in Scotland is **band D (61)**.

The potential rating shows the effect of undertaking all of the improvement measures listed within your recommendations report.
