Home Report

The Grange Fowlis Wester PH7 3NL

single survey

survey report on:

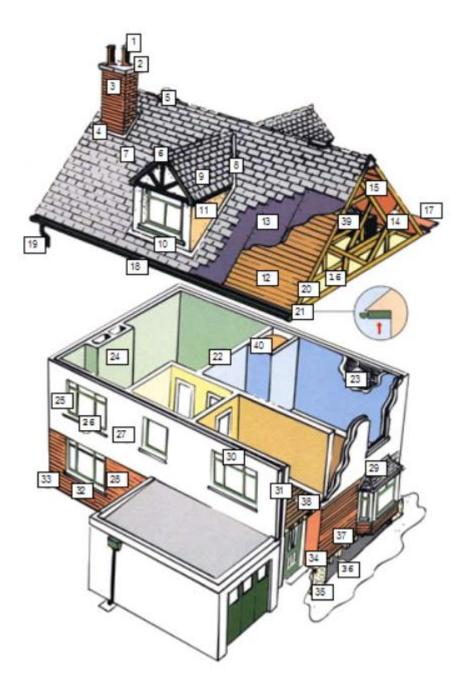
Sectional Diagram showing elements of a typical house

- Reference may be made in this report to some or all of the above component parts of the property. This diagram may assist you in locating and understanding these items.
- Chimney pots Coping stone 3 Chimney head **Flashing** Ridge ventilation Ridge board Slates/tiles Valley guttering Dormer projection 10 Dormer flashing 11 Dormer cheeks 12 Sarking 13 Roof felt 14 Trusses 15 Collar 16 Insulation 17 Parapet gutter 18 Eaves guttering 19 Rainwater downpipe 20 Verge boards / skews 21 Soffit boards 22 Partition wall 23 Lath / plaster 24 Chimney breast 25 Window pointing 26 Window sills 27 Rendering 28 Brickwork / pointing 29 Bay window 30 Lintels 31 Cavity walls / wall ties 32 Subfloor ventilator 33 Damp proof course
