Home Report

Mansefield

Alford

Single Survey and Mortgage Valuation Report

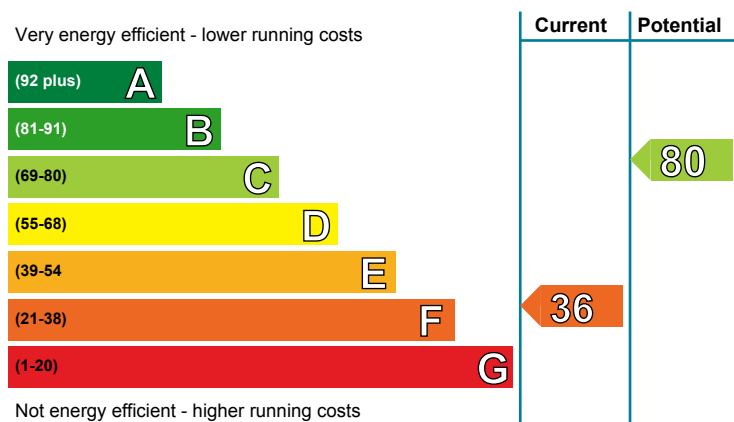
Energy Efficiency Rating

This graph shows the current efficiency of your home, taking into account both energy efficiency and fuel costs. The higher this rating, the lower your fuel bills are likely to be.

Your current rating is **band F (36)**. The average rating for EPCs in Scotland is **band D (61)**.

The potential rating shows the effect of undertaking all of the improvement measures listed within your recommendations report.
