HOME REPORT

Burnside
133 Clachtoll
Lochinver
IV27 4JD

DM HALL
CHARTERED SURVEYORS

Energy Performance Certificate (EPC)

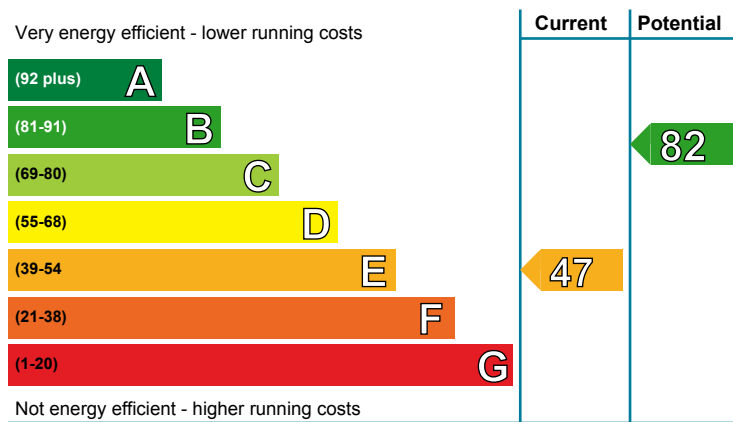
Energy Efficiency Rating

This graph shows the current efficiency of your home, taking into account both energy efficiency and fuel costs. The higher this rating, the lower your fuel bills are likely to be.

Your current rating is **band E (47)**. The average rating for EPCs in Scotland is **band D (61)**.

The potential rating shows the effect of undertaking all of the improvement measures listed within your recommendations report.
