HOME REPORT

HILLMOND STRATHERRICK ROAD

INVERNESS
IV2 4LU

Energy Performance Certificate (EPC)

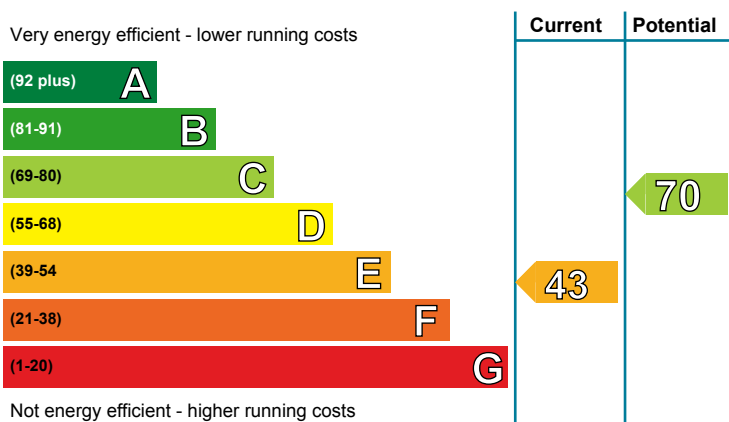
Energy Efficiency Rating

This graph shows the current efficiency of your home, taking into account both energy efficiency and fuel costs. The higher this rating, the lower your fuel bills are likely to be.

Your current rating is **band E (43)**. The average rating for EPCs in Scotland is **band D (61)**.

The potential rating shows the effect of undertaking all of the improvement measures listed within your recommendations report.

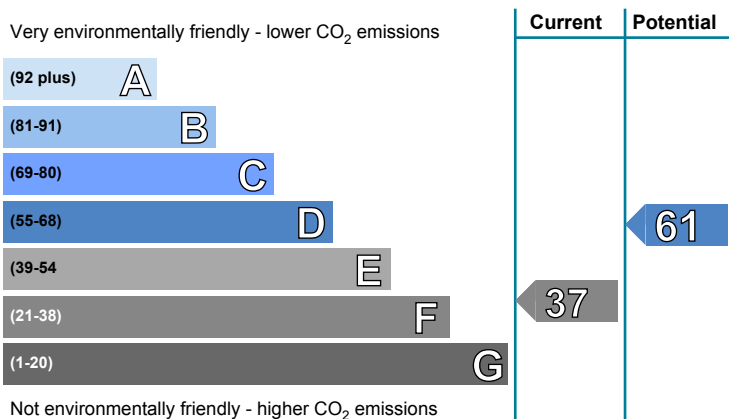
Environmental Impact (CO₂) Rating

This graph shows the effect of your home on the environment in terms of carbon dioxide (CO₂) emissions. The higher the rating, the less impact it has on the environment.

Your current rating is **band F (37)**. The average rating for EPCs in Scotland is **band D (59)**.

The potential rating shows the effect of undertaking all of the improvement measures listed within your recommendations report.
