YOUR ONESURVEY
HOME REPORT

5 Shore Street
Applecross, Strathcarron
IV54 8LR

SINGLE SURVEY

Surveyor Reference	I/25/02/098
Customer	Mr Stephen Deutsch & Mrs Annabelle Deutsch
Selling address	5 Shore Street Applecross, Strathcarron IV54 8LR
Date of Inspection	27/03/2025
Prepared by	James Burns, BSc MRICS Inverness - Allied Surveyors Scotland Ltd

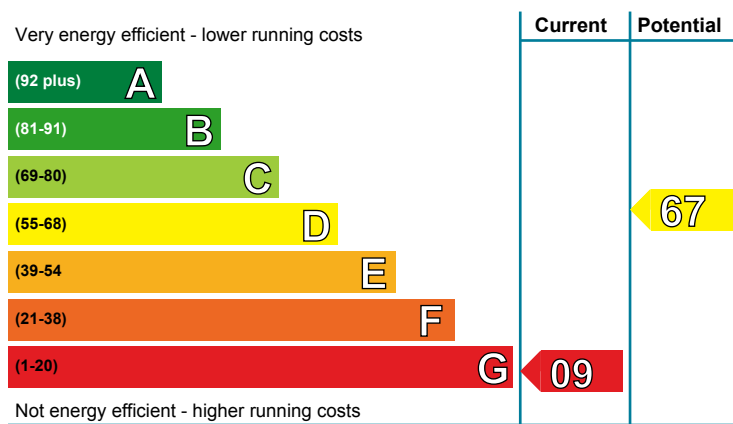
Energy Efficiency Rating

This graph shows the current efficiency of your home, taking into account both energy efficiency and fuel costs. The higher this rating, the lower your fuel bills are likely to be.

Your current rating is **band G (9)**. The average rating for EPCs in Scotland is **band D (61)**.

The potential rating shows the effect of undertaking all of the improvement measures listed within your recommendations report.

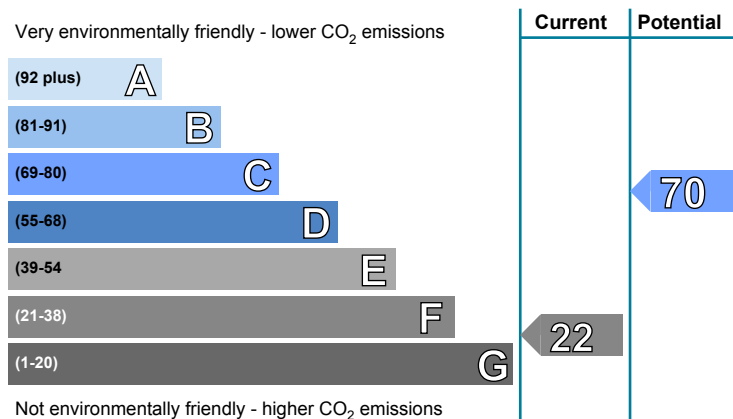
Environmental Impact (CO₂) Rating

This graph shows the effect of your home on the environment in terms of carbon dioxide (CO₂) emissions. The higher the rating, the less impact it has on the environment.
