SOUTH BURNSIDE YTHANBANK

Home Report

**Energy
Performance
Certificate**

Scottish Single Survey

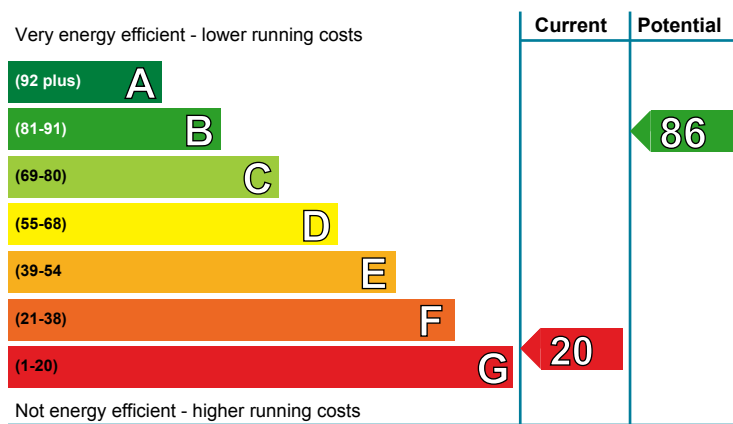
Energy Efficiency Rating

This graph shows the current efficiency of your home, taking into account both energy efficiency and fuel costs. The higher this rating, the lower your fuel bills are likely to be.

Your current rating is **band G (20)**. The average rating for EPCs in Scotland is **band D (61)**.

The potential rating shows the effect of undertaking all of the improvement measures listed within your recommendations report.

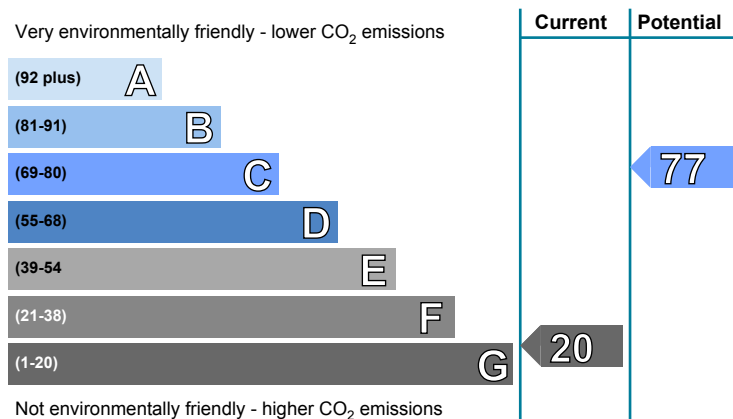
Environmental Impact (CO₂) Rating

This graph shows the effect of your home on the environment in terms of carbon dioxide (CO₂) emissions. The higher the rating, the less impact it has on the environment.

The potential rating shows the effect of undertaking all of the improvement measures listed within your recommendations report.
