# Home Report

The Brae  
Alyth Blairgowrie PH11 8JG

# single survey

## survey report on:

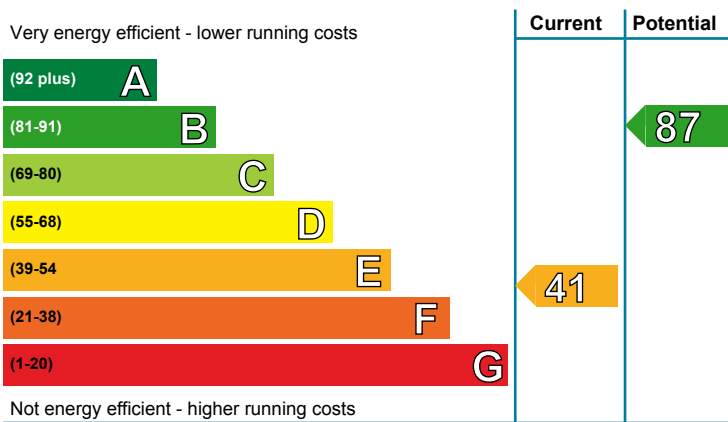
## Energy Efficiency Rating

This graph shows the current efficiency of your home, taking into account both energy efficiency and fuel costs. The higher this rating, the lower your fuel bills are likely to be.

Your current rating is **band E (41)**. The average rating for EPCs in Scotland is **band D (61)**.

The potential rating shows the effect of undertaking all of the improvement measures listed within your recommendations report.
