HOME REPORT

CRAIGALLEN, SEABANK ROAD, STRANRAER, DG9 0EF

Dwelling type: Detached house
Date of assessment: 05 September 2024
Date of certificate: 06 September 2024
Total floor area: 232 m²
Primary Energy Indicator: 223 kWh/m²/year

Single Survey

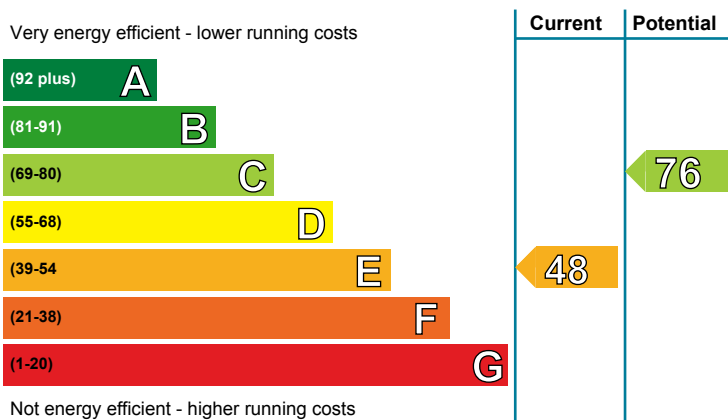
Energy Efficiency Rating

This graph shows the current efficiency of your home, taking into account both energy efficiency and fuel costs. The higher this rating, the lower your fuel bills are likely to be.

Your current rating is **band E (48)**. The average rating for EPCs in Scotland is **band D (61)**.

The potential rating shows the effect of undertaking all of the improvement measures listed within your recommendations report.
