Home Report

Scottish Single Survey

Property address	Colislinn Steadings Newmill On Slitrig Hawick TD9 9UQ
Customer	Mr Malcolm and Mrs Alithea Lockie
Customer address	Colislinn Steadings Newmill On Slitrig Hawick TD9 9UQ
Prepared by	Shepherd Chartered Surveyors
Date of inspection	03/06/2024

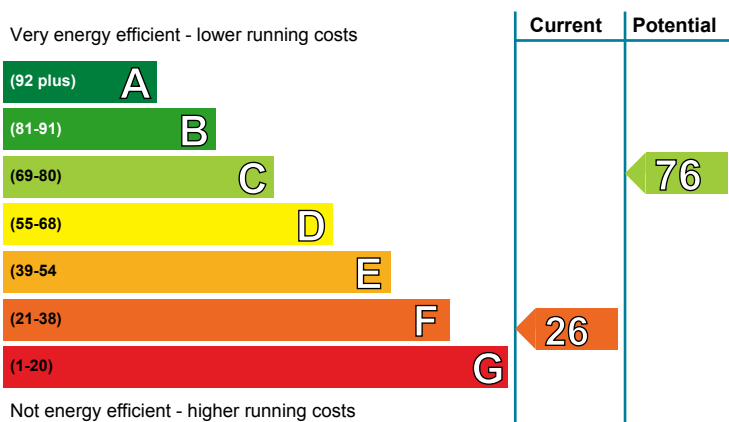
Energy Efficiency Rating

This graph shows the current efficiency of your home, taking into account both energy efficiency and fuel costs. The higher this rating, the lower your fuel bills are likely to be.

Your current rating is **band F (26)**. The average rating for EPCs in Scotland is **band D (61)**.

The potential rating shows the effect of undertaking all of the improvement measures listed within your recommendations report.

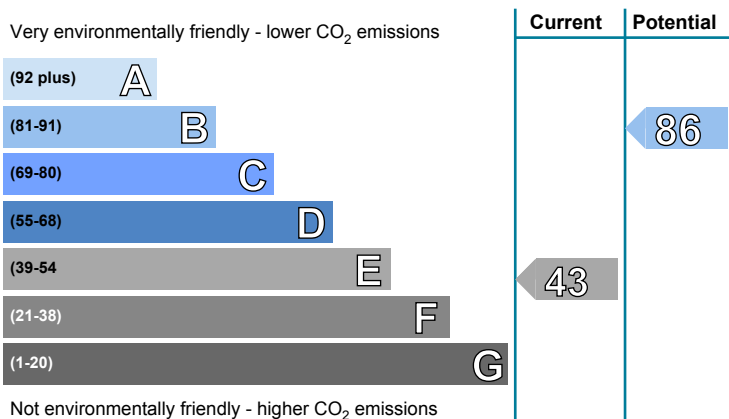
Environmental Impact (CO₂) Rating

This graph shows the effect of your home on the environment in terms of carbon dioxide (CO₂) emissions. The higher the rating, the less impact it has on the environment.
