Home Report

Scottish Single Survey

Property address	Janelea Douglas Hall Dalbeattie DG5 4PX
Customer	Ms H Scott
Customer address	Janelea Douglas Hall Dalbeattie DG5 4PX
Prepared by	Shepherd Chartered Surveyors
Date of inspection	10/06/2024

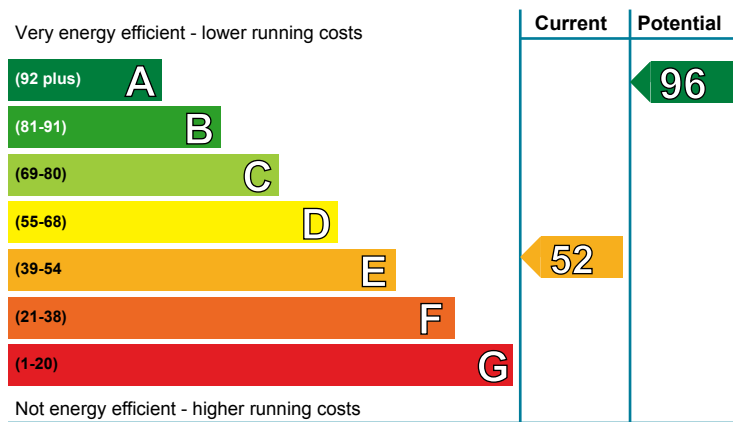
Energy Efficiency Rating

This graph shows the current efficiency of your home, taking into account both energy efficiency and fuel costs. The higher this rating, the lower your fuel bills are likely to be.

Your current rating is **band E (52)**. The average rating for EPCs in Scotland is **band D (61)**.

The potential rating shows the effect of undertaking all of the improvement measures listed within your recommendations report.

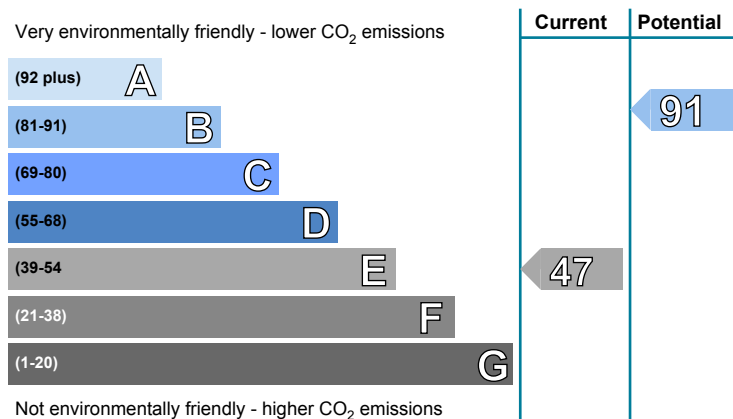
Environmental Impact (CO₂) Rating

This graph shows the effect of your home on the environment in terms of carbon dioxide (CO₂) emissions. The higher the rating, the less impact it has on the environment.
