Home Report

Bennathie House
Bendochy Coupar Angus PH13 9HN

Single Survey

Survey report on:

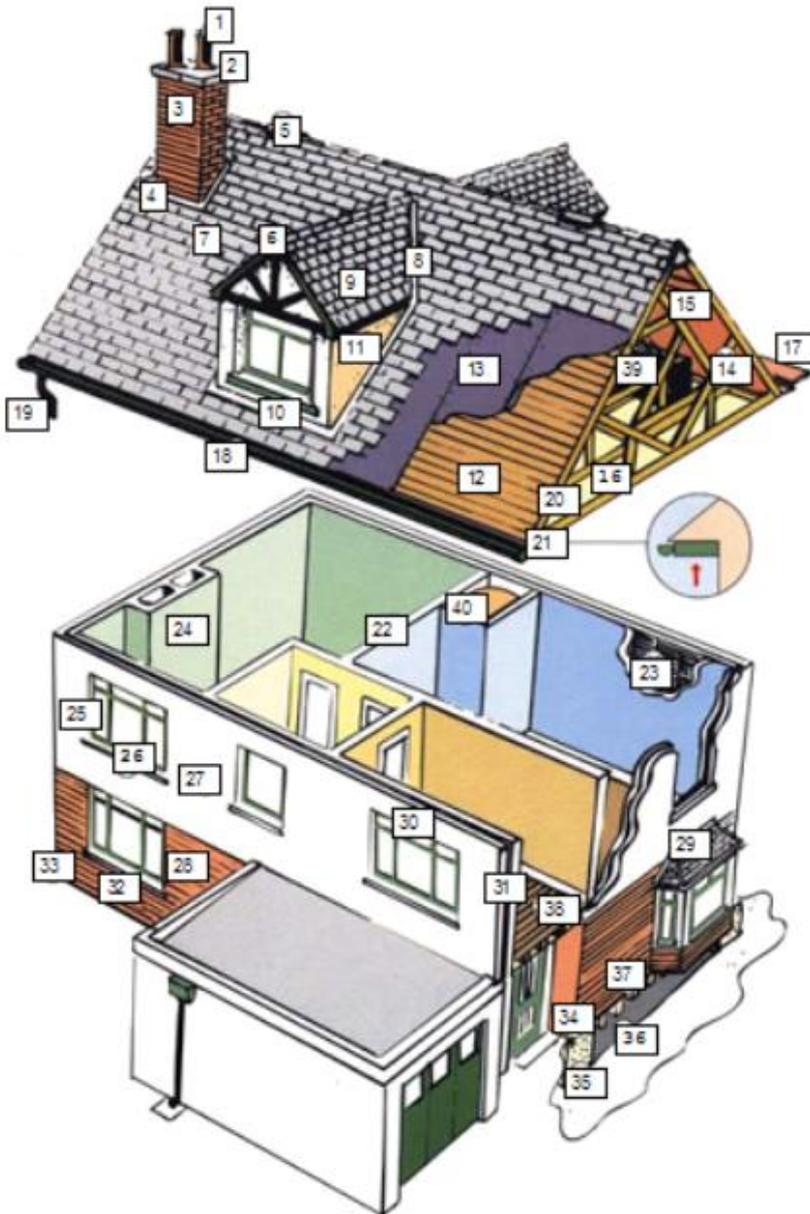
Sectional diagram showing elements of a typical house

| 1 | Chimney pots |
| 2 | Coping stone |
| 35 | Foundations |

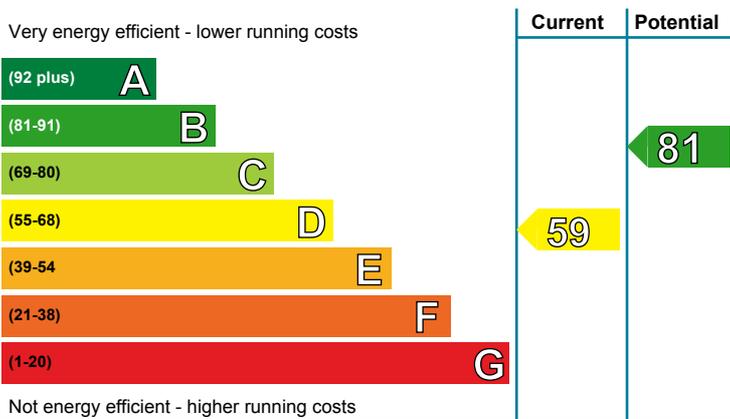
Energy Efficiency Rating

This graph shows the current efficiency of your home, taking into account both energy efficiency and fuel costs. The higher this rating, the lower your fuel bills are likely to be.

Your current rating is **band D (59)**. The average rating for EPCs in Scotland is **band D (61)**.

The potential rating shows the effect of undertaking all of the improvement measures listed within your recommendations report.

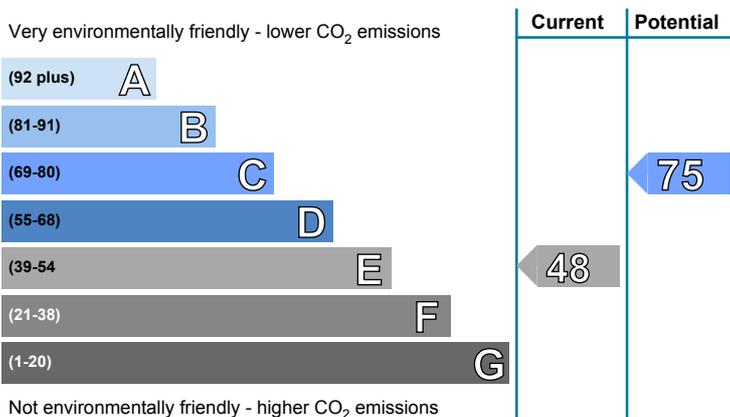
Environmental Impact (CO₂) Rating

This graph shows the effect of your home on the environment in terms of carbon dioxide (CO₂) emissions. The higher the rating, the less impact it has on the environment.
