Kippilaw Glen

Home Report

Energy Performance Certificate

KIPPILAW GLEN COTTAGE BOWDEN, MELROSE, TD6 9HF

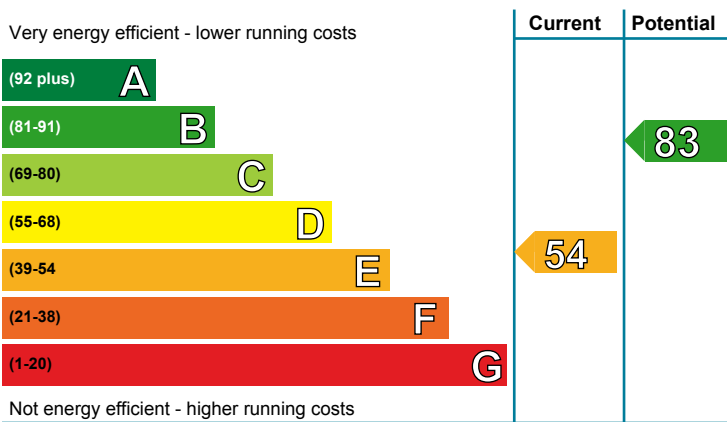
Energy Efficiency Rating

This graph shows the current efficiency of your home, taking into account both energy efficiency and fuel costs. The higher this rating, the lower your fuel bills are likely to be.

Your current rating is **band E (54)**. The average rating for EPCs in Scotland is **band D (61)**.

The potential rating shows the effect of undertaking all of the improvement measures listed within your recommendations report.

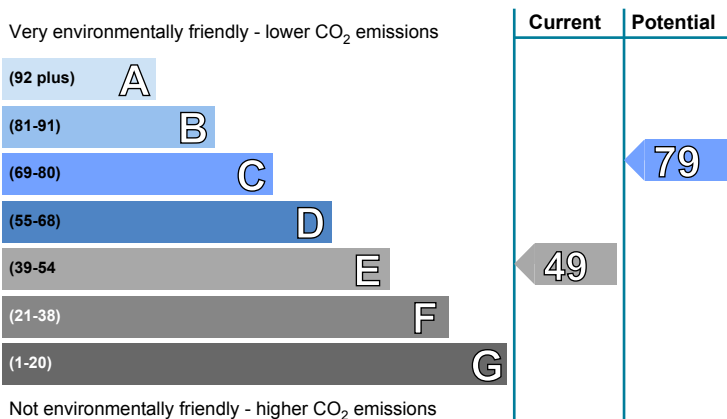
Environmental Impact (CO₂) Rating

This graph shows the effect of your home on the environment in terms of carbon dioxide (CO₂) emissions. The higher the rating, the less impact it has on the environment.

Your current rating is **band E (49)**. The average rating for EPCs in Scotland is **band D (59)**.

The potential rating shows the effect of undertaking all of the improvement measures listed within your recommendations report.
