YOUR ONESURVEY
HOME REPORT

Holmes Cottage
Galston Road
Hurlford, Kilmarnock
KA1 5JD

SINGLE SURVEY

Single Survey

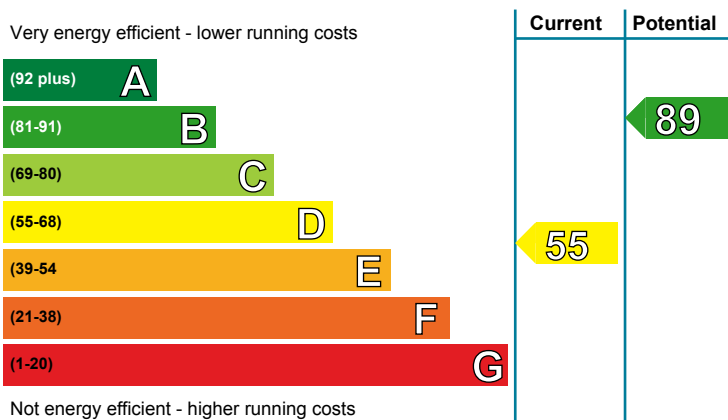
Energy Efficiency Rating

This graph shows the current efficiency of your home, taking into account both energy efficiency and fuel costs. The higher this rating, the lower your fuel bills are likely to be.

Your current rating is **band D (55)**. The average rating for EPCs in Scotland is **band D (61)**.

The potential rating shows the effect of undertaking all of the improvement measures listed within your recommendations report.
