YOUR ONESURVEY  
**HOME REPORT**

South Craig Farm  
West Of Drongan  
Hollybush, Ayr  
KA6 6HB

# SINGLE SURVEY

A report on the condition of the property, with categories being rated from 1 to 3.

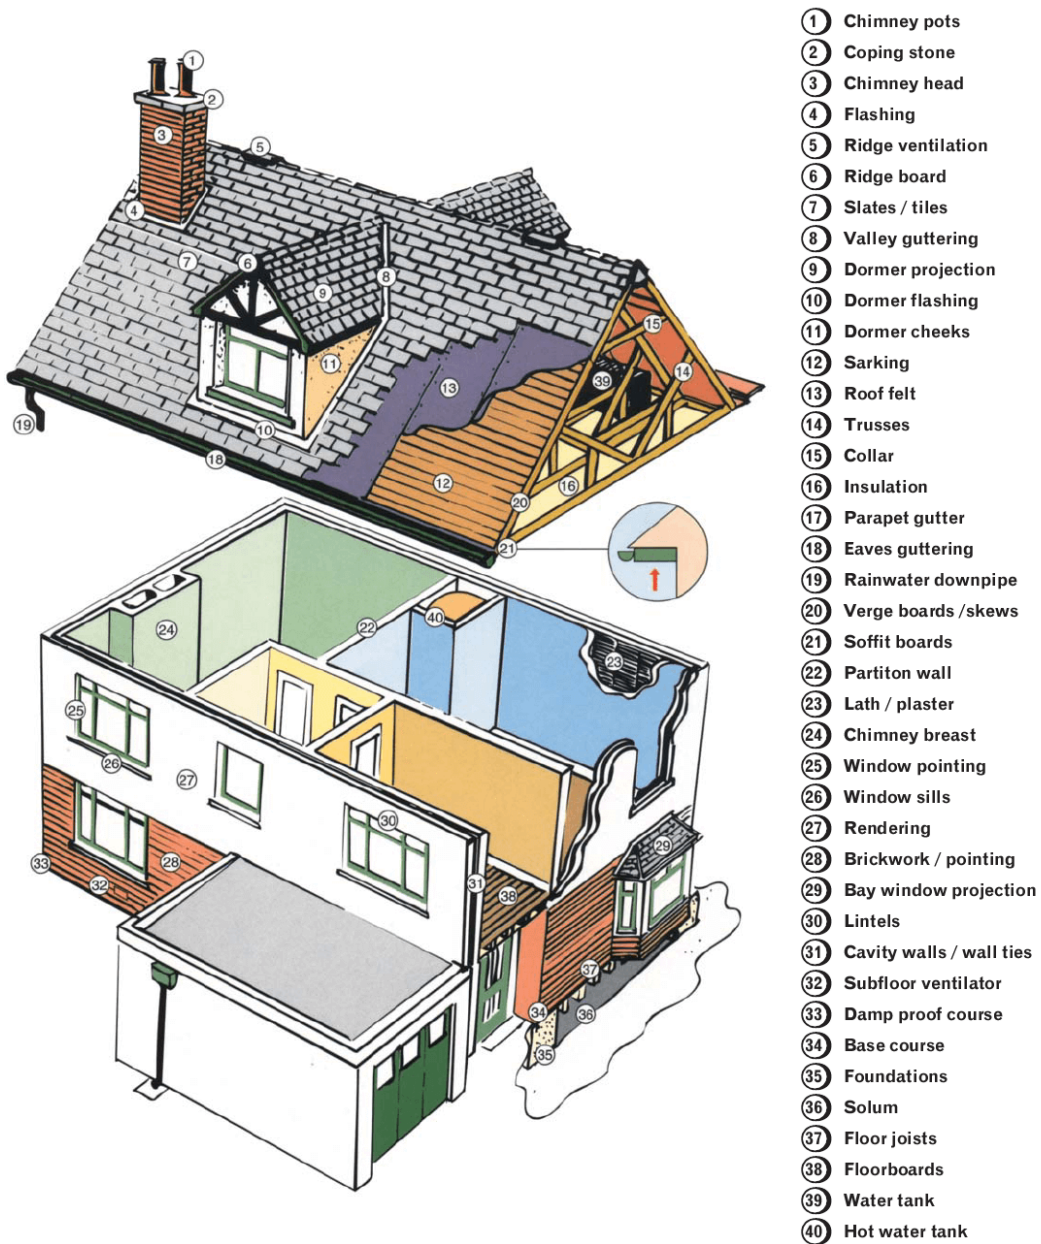
## Sectional Diagram showing elements of a typical house

Reference may be made in this report to some or all of the above component parts of the property. This diagram may assist you in locating and understanding these items.
