FAIRFIELD FARM MOSCOW

Home Report

FAIRFIELD FARM, MOSCOW, GALSTON, KA4 8PJ

Scottish Single Survey

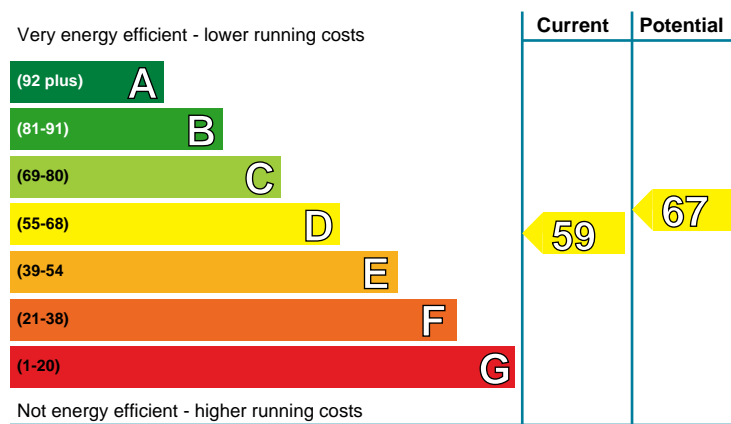
Energy Efficiency Rating

This graph shows the current efficiency of your home, taking into account both energy efficiency and fuel costs. The higher this rating, the lower your fuel bills are likely to be.

Your current rating is **band D (59)**. The average rating for EPCs in Scotland is **band D (61)**.

The potential rating shows the effect of undertaking all of the improvement measures listed within your recommendations report.

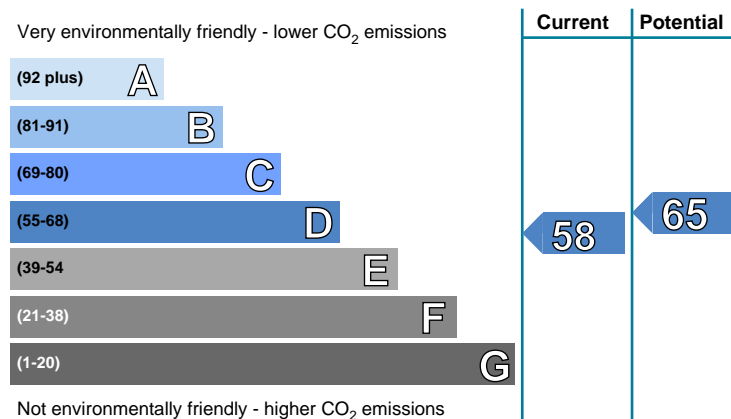
Environmental Impact (CO₂) Rating

This graph shows the effect of your home on the environment in terms of carbon dioxide (CO₂) emissions. The higher the rating, the less impact it has on the environment.

Your current rating is **band D (58)**. The average rating for EPCs in Scotland is **band D (59)**.

The potential rating shows the effect of undertaking all of the improvement measures listed within your recommendations report.
