Home Report

Tigh-Na-Bruaich
Keltneyburn Aberfeldy PH15 2LE

Single Survey

Property Address	Tigh-Na-Bruaich Aberfeldy PH15 2LE
Customer	Mr Richard Finlinson
Prepared by	Graham + Sibbald LLP
Date of Inspection	03/03/2025

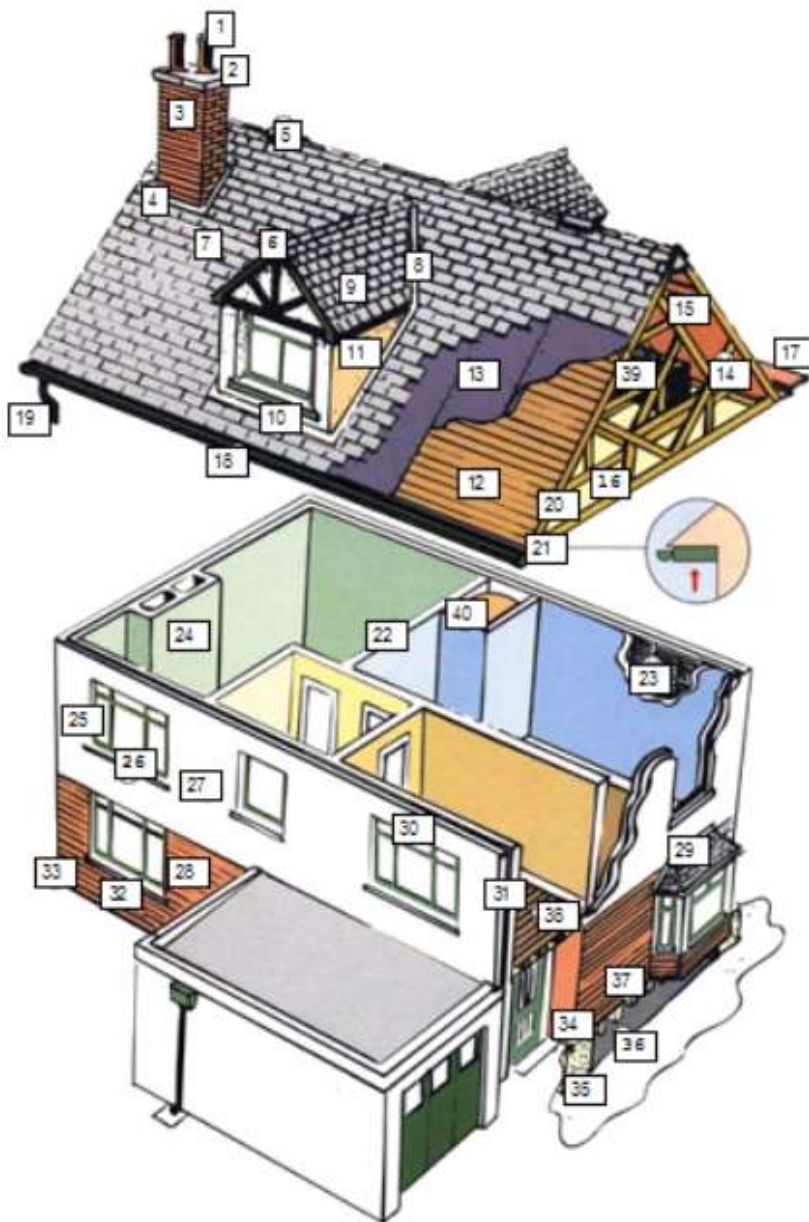
Sectional diagram showing elements of a typical house

1	Chimney pots
2	Coping stone
3	Chimney head
4	Flashing
5	Ridge ventilation
6	Ridge board
7	Slates / tiles
8	Valley guttering
9	Dormer projection
10	Dormer flashing
11	Dormer cheeks
12	Sarking
13	Roof felt
14	Trusses
15	Collar
16	Insulation
17	Parapet gutter
18	Eaves guttering
19	Rainwater downpipe
20	Verge boards / skewes
21	Soffit boards
22	Partition wall
23	Lath / plaster
24	Chimney breast
25	Window pointing
26	Window sills
27	Rendering
28	Brickwork / pointing
29	Bay window projection
30	Lintels
31	Cavity walls / wall ties
32	Subfloor ventilator
33	Damp proof course
34	Base course
35	Foundations
36	Solum
37	Floor joists
38	Floorboards
39	Water tank
40	Hot water tank

Reference may be made in this report to some or all of the above component parts of the property. This diagram may assist you in locating and understanding these items.

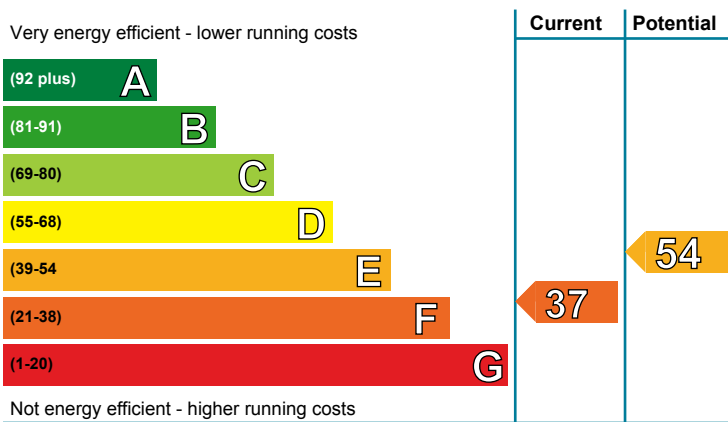
Energy Efficiency Rating

This graph shows the current efficiency of your home, taking into account both energy efficiency and fuel costs. The higher this rating, the lower your fuel bills are likely to be.

Your current rating is **band F (37)**. The average rating for EPCs in Scotland is **band D (61)**.

The potential rating shows the effect of undertaking all of the improvement measures listed within your recommendations report.

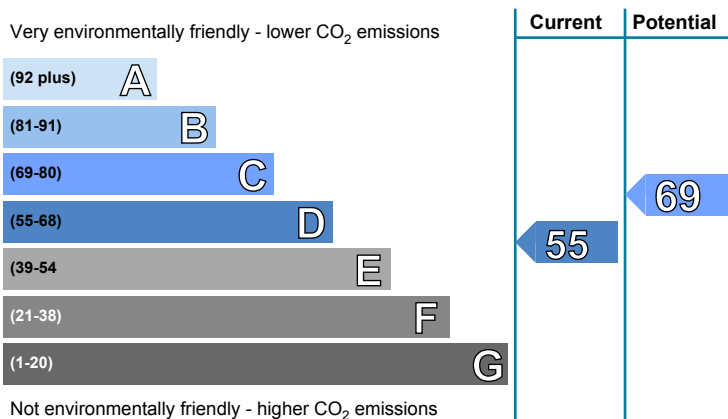
Environmental Impact (CO₂) Rating

This graph shows the effect of your home on the environment in terms of carbon dioxide (CO₂) emissions. The higher the rating, the less impact it has on the environment.
