HOME REPORT

Energy Performance Certificate (EPC)

KIRROUGHTREE MILL, NEWTON STEWART, DG8 7AJ

Dwelling type: Detached house
Date of assessment: 16 January 2025
Date of certificate: 19 January 2025
Total floor area: 169 m²
Primary Energy Indicator: 125 kWh/m²/year

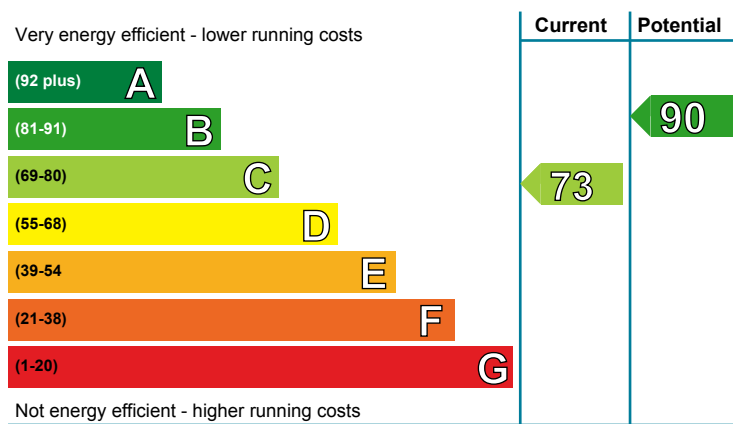
Energy Efficiency Rating

This graph shows the current efficiency of your home, taking into account both energy efficiency and fuel costs. The higher this rating, the lower your fuel bills are likely to be.

Your current rating is **band C (73)**. The average rating for EPCs in Scotland is **band D (61)**.

The potential rating shows the effect of undertaking all of the improvement measures listed within your recommendations report.

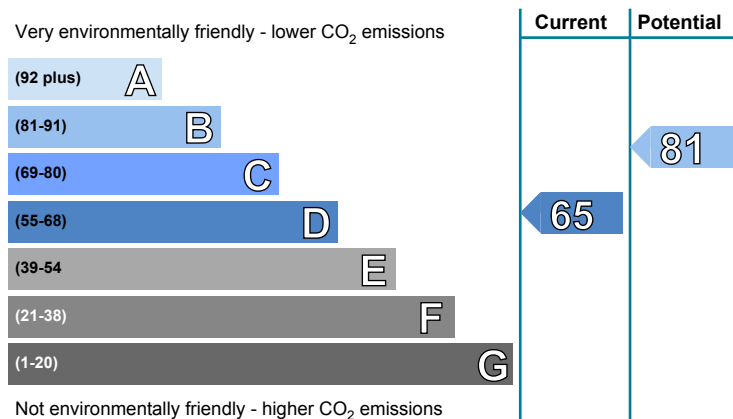
Environmental Impact (CO₂) Rating

This graph shows the effect of your home on the environment in terms of carbon dioxide (CO₂) emissions. The higher the rating, the less impact it has on the environment.

Your current rating is **band D (65)**. The average rating for EPCs in Scotland is **band D (59)**.

The potential rating shows the effect of undertaking all of the improvement measures listed within your recommendations report.
